**CANOE BROOK RESERVOIR  
NO. 3 DAM**

**CANOE BROOK RESERVOIR  
NO. 3 DIKE**

**3 PHASE I INSPECTION REPORT  
NATIONAL DAM SAFETY PROGRAM.**

PHASE I REPORT  
NATIONAL DAM SAFETY PROGRAM

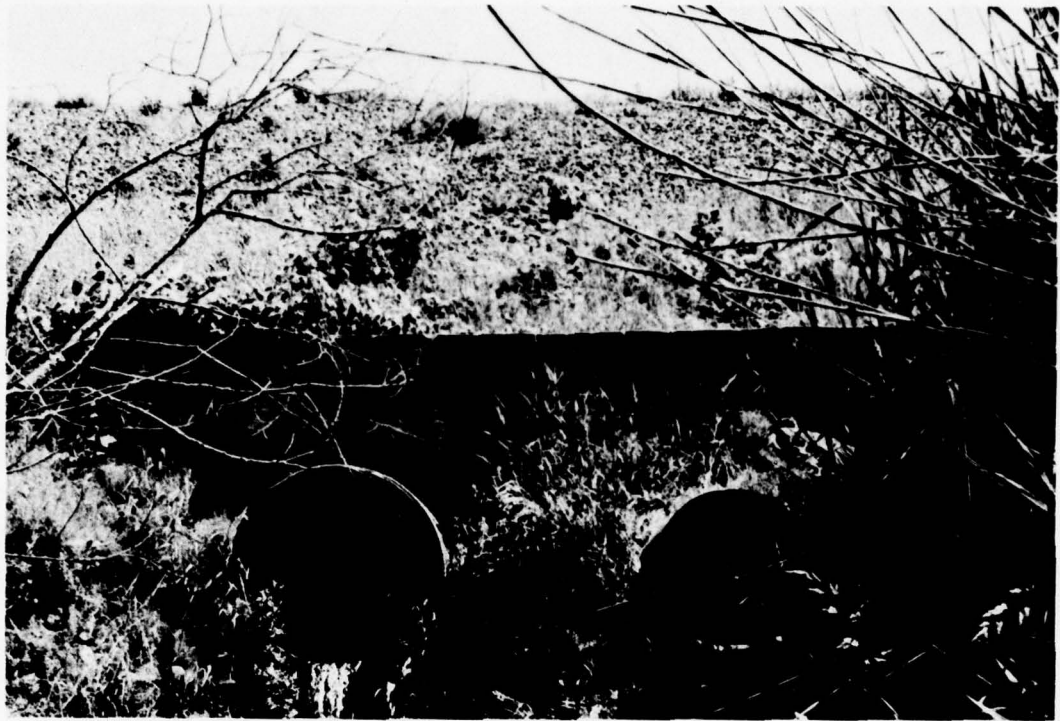
**PHOTO 1**

The 24 inch diameter relief well and reservoir outlet pipe discharging from the headwall at the downstream toe of the dam was functioning but it was about one-half full of sediment. No other deficiencies were observed in the visible section of this pipe.

A scour pit several feet in length and breadth and about two feet deep had developed in the stream channel immediately downstream from the headwall from which the above-mentioned 24 inch pipe and the 36 inch storm drain discharge. No deficiencies were observed in the visible section of the 36 inch pipe.

- Photo 1 - View Upstream (Southeast) at Dam Showing Center of Downstream Slope; Concrete Headwall has 36 Inch Storm Drain Outlet on Left, 24 Inch Outlet for Reservoir and Foundation Relief Wells on Right - 14 June 1978.

- 1) The toe drain outlet(s) on the left side of the downstream slope should be immediately located and cleaned as necessary.
- 2) The eight inch toe drain outlet located about 40 feet east of the headwall should be cleaned.
- 3) The 24 inch relief well and reservoir outlet pipe should be cleaned, inspected, and repaired as necessary.

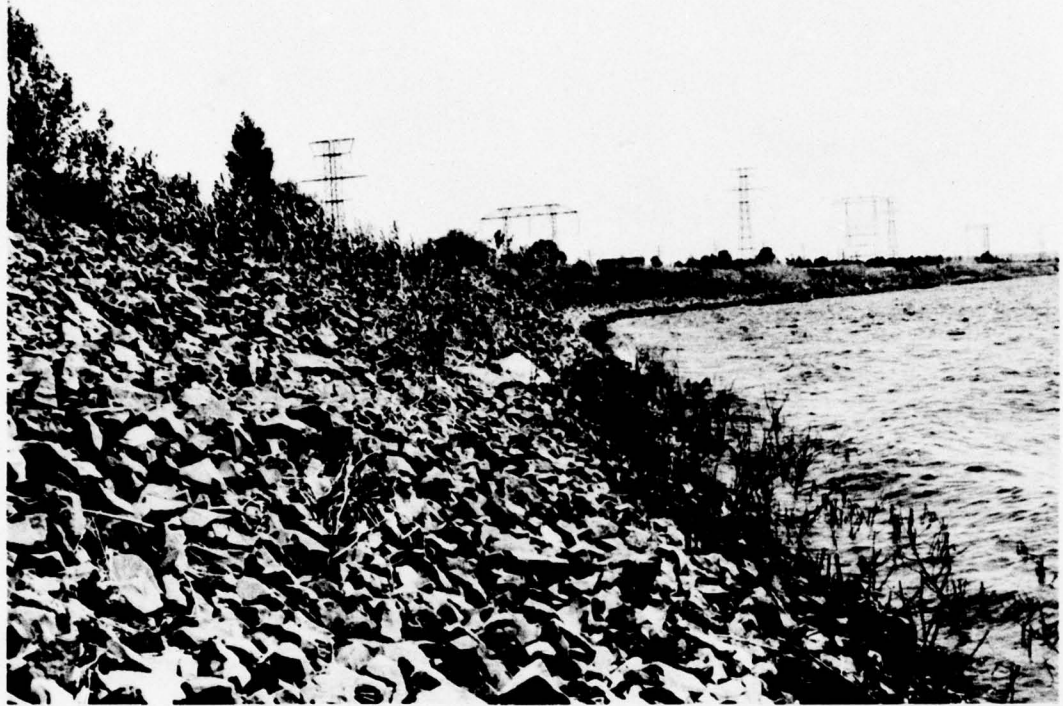
**PHOTO 7**

Riprap failures were noted at numerous locations in the inner dike slope. The most severe of these were along the south dike where the most severe wave action occurs.

- Photo 7 - View Southwest Along Inside Dike Slope from North End of East Dike Section; Areas of Riprap Damage and Riprap Repair on Right Side of Photo - 14 June 1978.

Several of the riprap failures along the inside of the south dike slope are considered severe enough to require immediate attention. Other riprap failures along the inner dike slope were relatively superficial and have a lower priority for repairs. Riprap stone used in the repairs should be of adequate size, i.e., larger than much of the present riprap and free of decomposable rocks, such as shales. It may also be necessary to include appropriate granular bedding beneath the riprap in some of the more severely eroded areas.

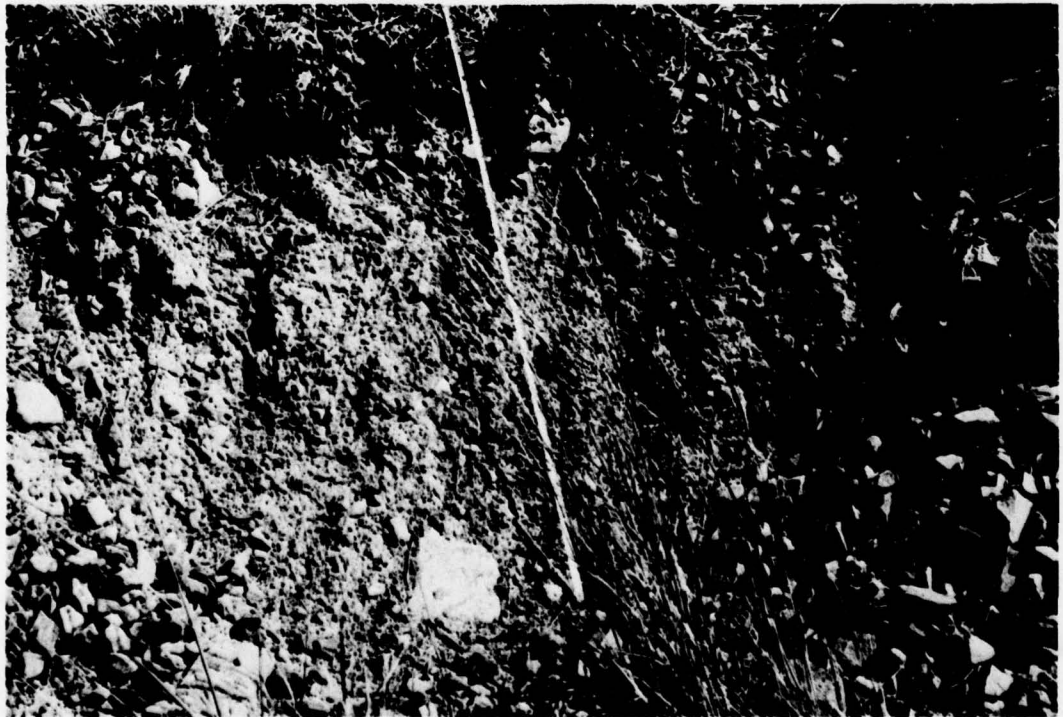
**PHOTO 8**

- Photo 8 - Close-up of Severe Riprap Failure and Wave Erosion on Inside Slope of South Dike Section About 40 Feet East of Reservoir Inlet/Outlet Pipe; Tape Segment in Photo is 3.5 Feet Long - 14 June 1978.

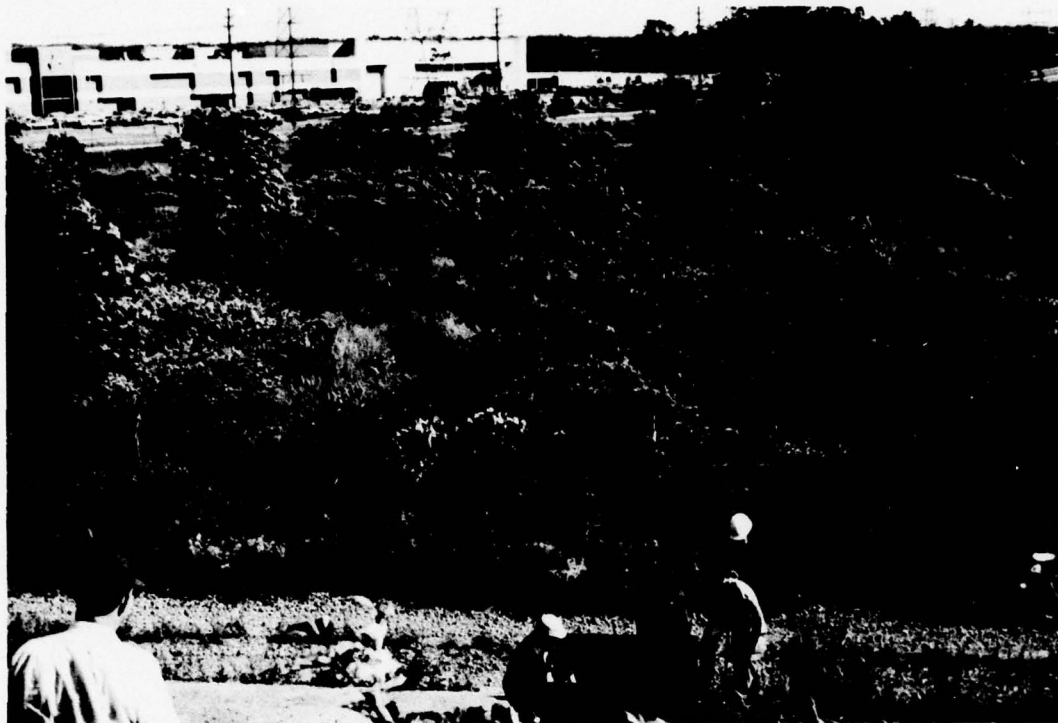
**PHOTO 9**

Photo 9 - View South From Crest of South Dike Section Over  
Pump Vault on Reservoir Inlet/Outlet Pipe; Livingston  
Mall Behind Eisenhower Parkway at Top of Photo -  
14 June 1978.

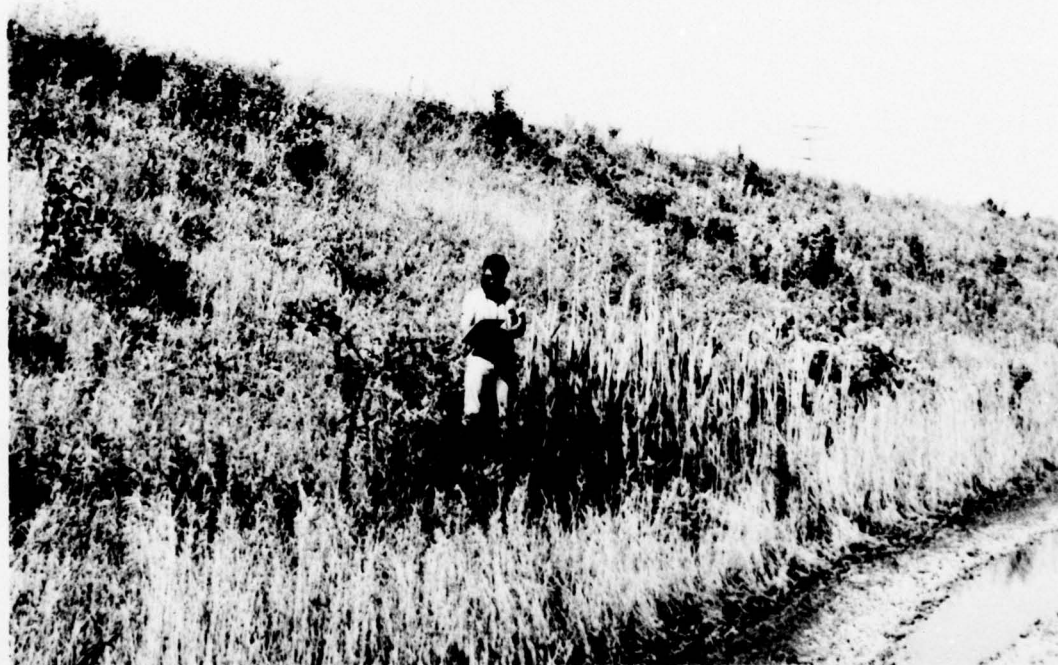
**PHOTO 10**

- c. Dike - A seepage area approximately 70 feet long was noted along the outer dike toe extending easterly from a point about 30 feet east of the 30 inch diameter inlet/outlet pipe and pump vault. No sand boils or piping evidence were observed. This was inferred to be an area of long-term steady seepage along the natural ground line beneath the dike. Total estimated flow in the seepage area was on the order of two to three G.P.M.

Photo 10 - Seepage Area at Outside Toe of South Dike About  
50 feet East of Pump Vault (Photo 9) - 14 June 1978.

- c. Dike - The seepage area located along the outer toe of the south dike, east of the pump vault, is not considered to be indicative of a condition which endangers the structural stability of the dike at the present time. This seepage area should be visually monitored by the owner's personnel and any others who make future inspections of the dike. A small ditch might be excavated to collect seepage water and a drain pipe might be installed to carry the water south under the driveway.
